Big West Building Services, LLC

Bigfork Library Roof Assessment

Section 1

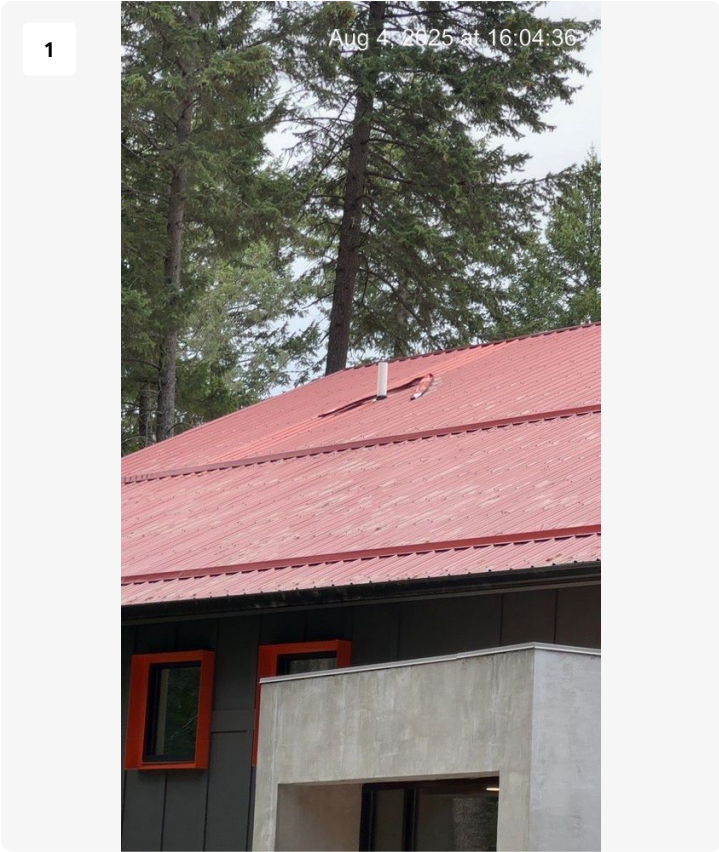
Damaged snowbreak around pipe penetration on South Elevation. Recommend replacement of snowbreak prior to winter conditions.

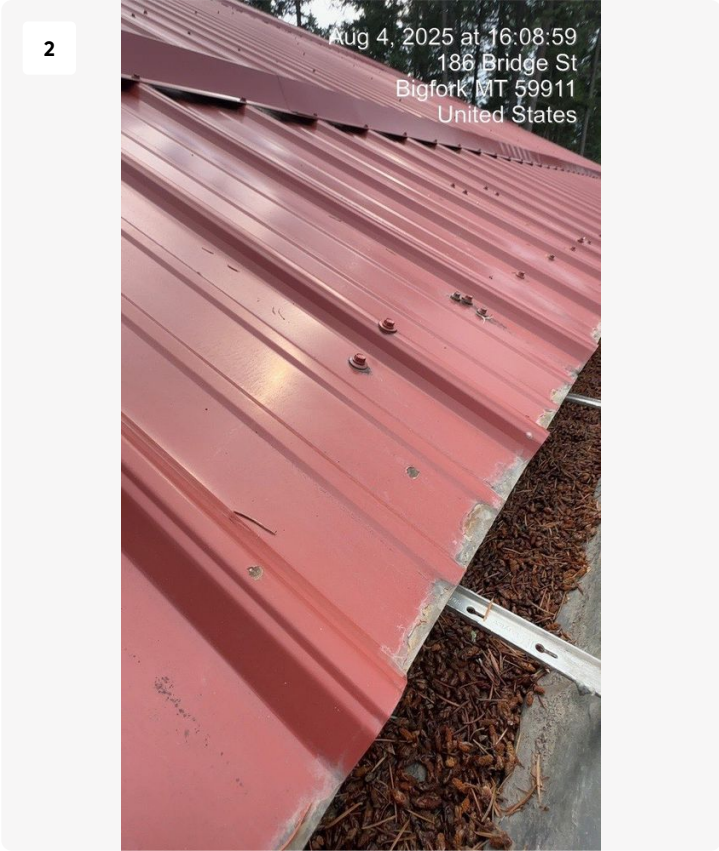
South elevation roof panels at eave paint deterioration and corrosion due to high moisture content. Likely due to prolonged gutter clogging and moisture retention along eave. Debris currently in gutters. Recommend gutter guards be installed.

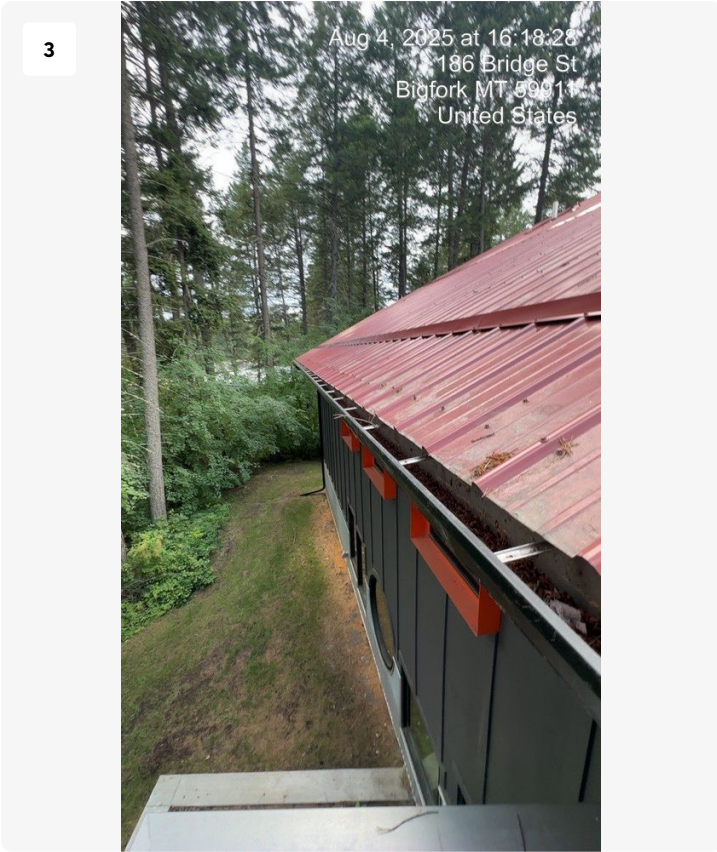
South elevation roof panels at eave paint deterioration and corrosion due to high moisture content. Likely due to prolonged gutter clogging and moisture retention along eave. Debris currently in gutters. Recommend gutter guards be installed.

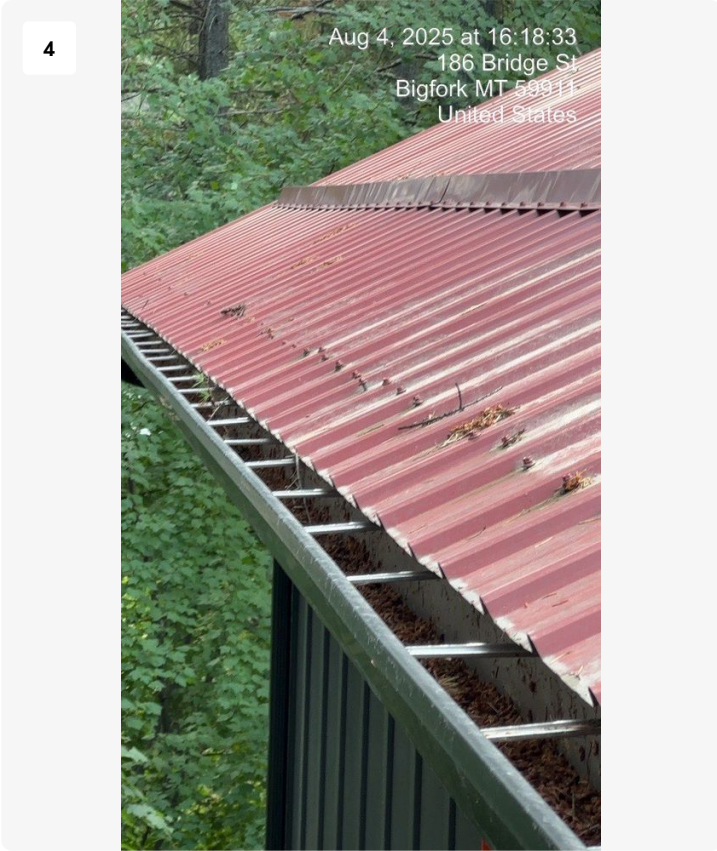
South elevation roof panels at eave paint deterioration and corrosion due to high moisture content. Likely due to prolonged gutter clogging and moisture retention along eave. Debris currently in gutters. Recommend gutter guards be installed.

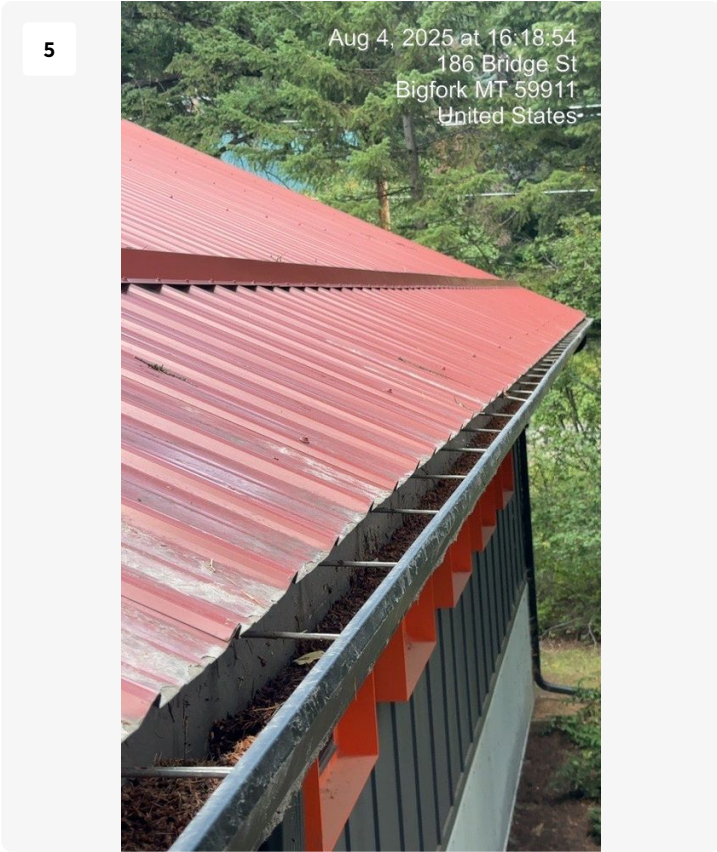
South elevation roof panels at eave paint deterioration and corrosion due to high moisture content. Likely due to prolonged gutter clogging and moisture retention along eave. Debris currently in gutters. Recommend gutter guards be installed.

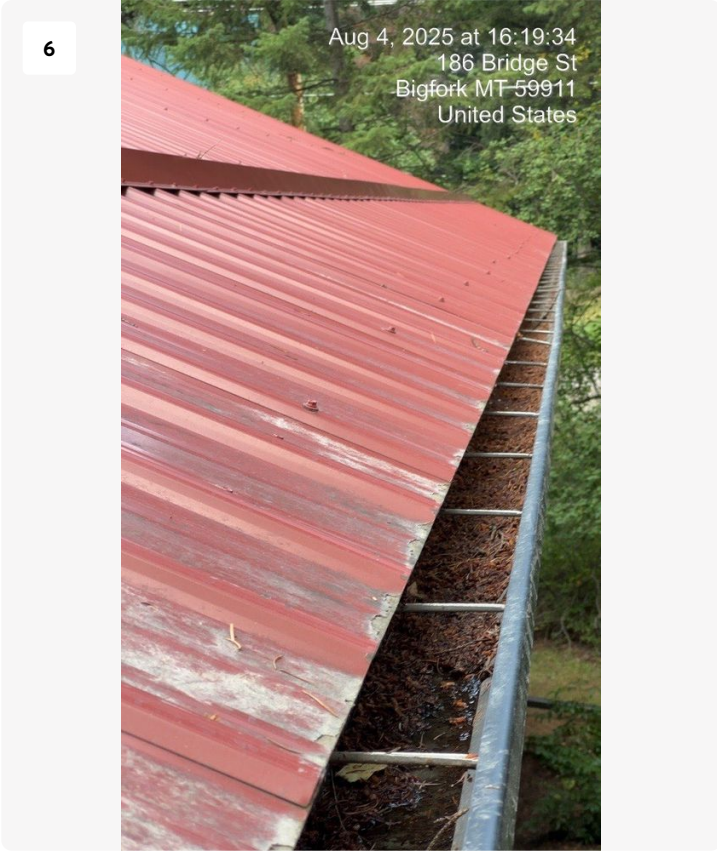
South elevation roof panels at eave paint deterioration and corrosion due to high moisture content. Likely due to prolonged gutter clogging and moisture retention along eave. Debris currently in gutters. Recommend gutter guards be installed.

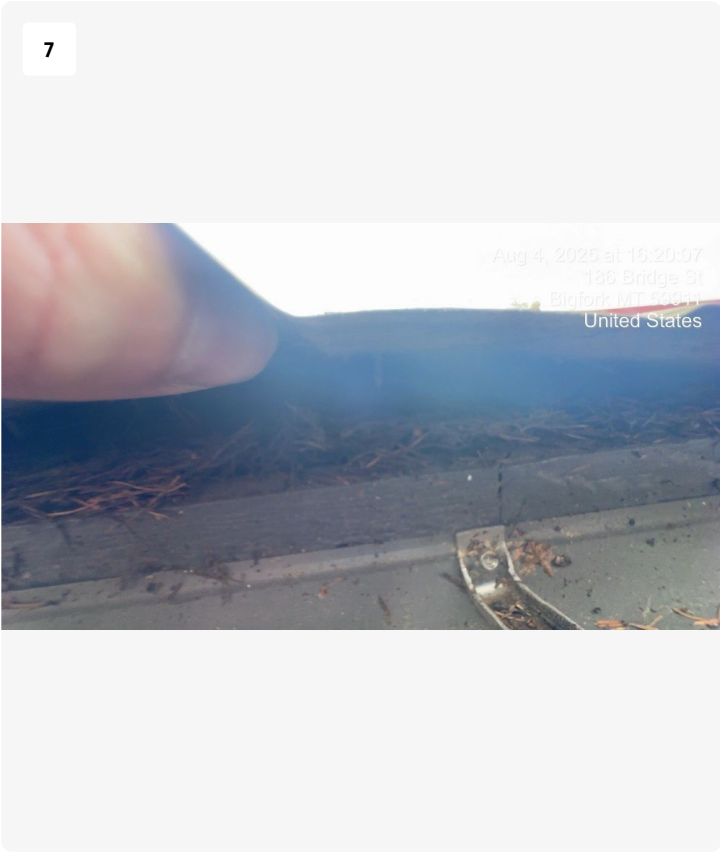
Moisture logged roof decking - rotted and deteriorated; leading to roof fasteners pulling out and loosing uplift strength. Pine needles present under roof eave indicating backing up of gutter debris and absorption of moisture into roof deck.

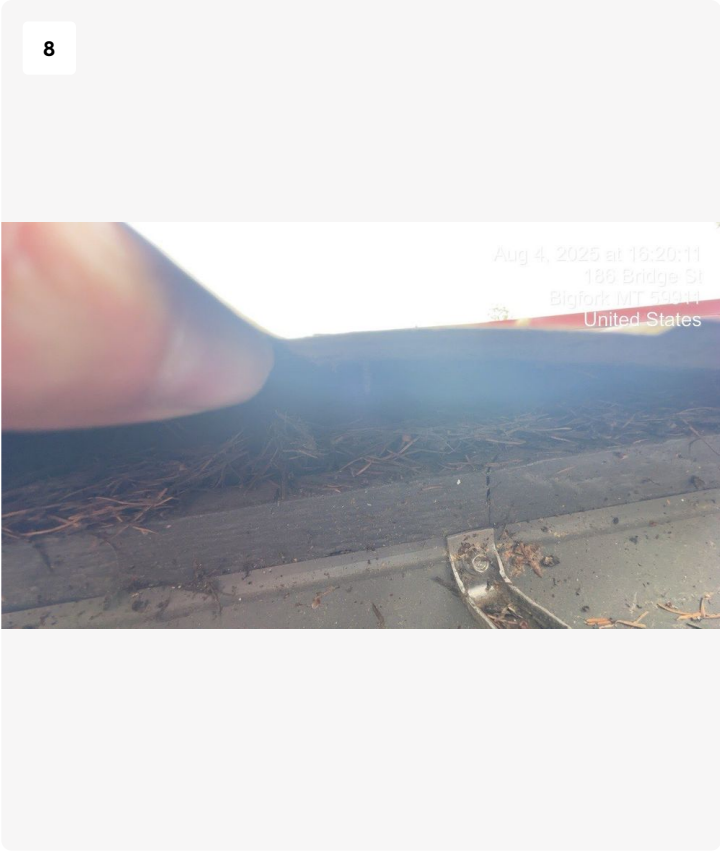
Moisture logged roof decking - rotted and deteriorated; leading to roof fasteners pulling out and loosing uplift strength. Pine needles present under roof eave indicating backing up of gutter debris and absorption of moisture into roof deck.

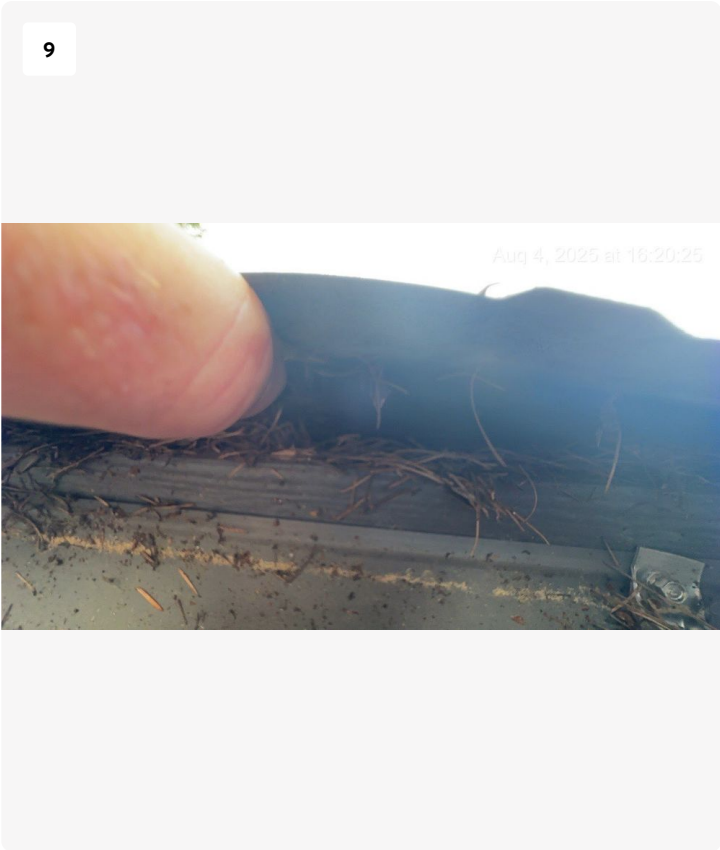
Moisture logged roof decking - rotted and deteriorated; leading to roof fasteners pulling out and loosing uplift strength. Pine needles present under roof eave indicating backing up of gutter debris and absorption of moisture into roof deck.

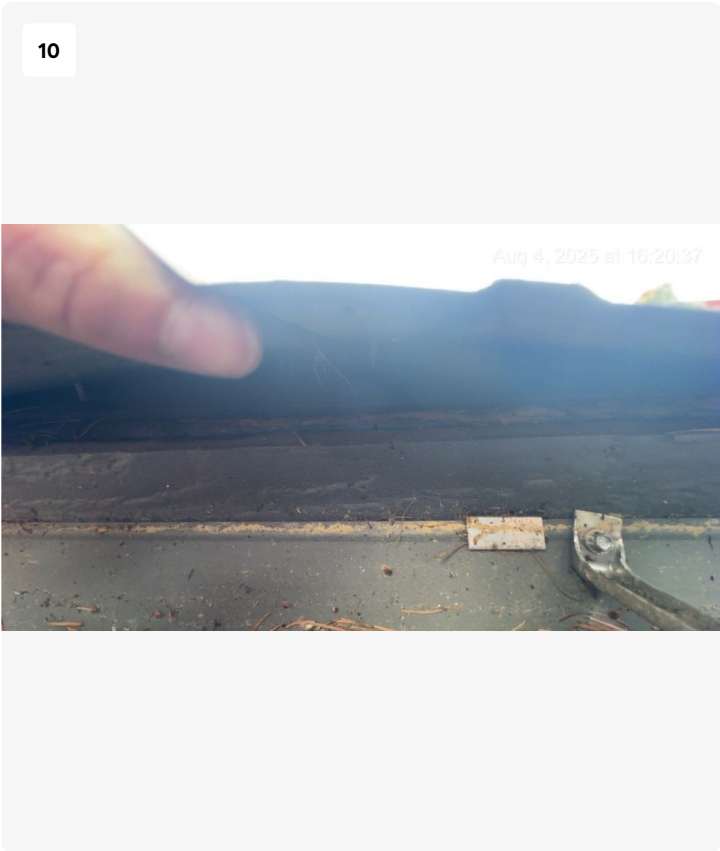
Moisture logged roof decking - rotted and deteriorated; leading to roof fasteners pulling out and loosing uplift strength. Pine needles present under roof eave indicating backing up of gutter debris and absorption of moisture into roof deck.
